Nave Roof Preliminary Assessment Ross Cook

Preliminary Inspection of the Painted Nave Roof Dr Andrea Kirkham ACR FSA

Nave Roof, Christchurch Priory, Dorset

Preliminary Assessment

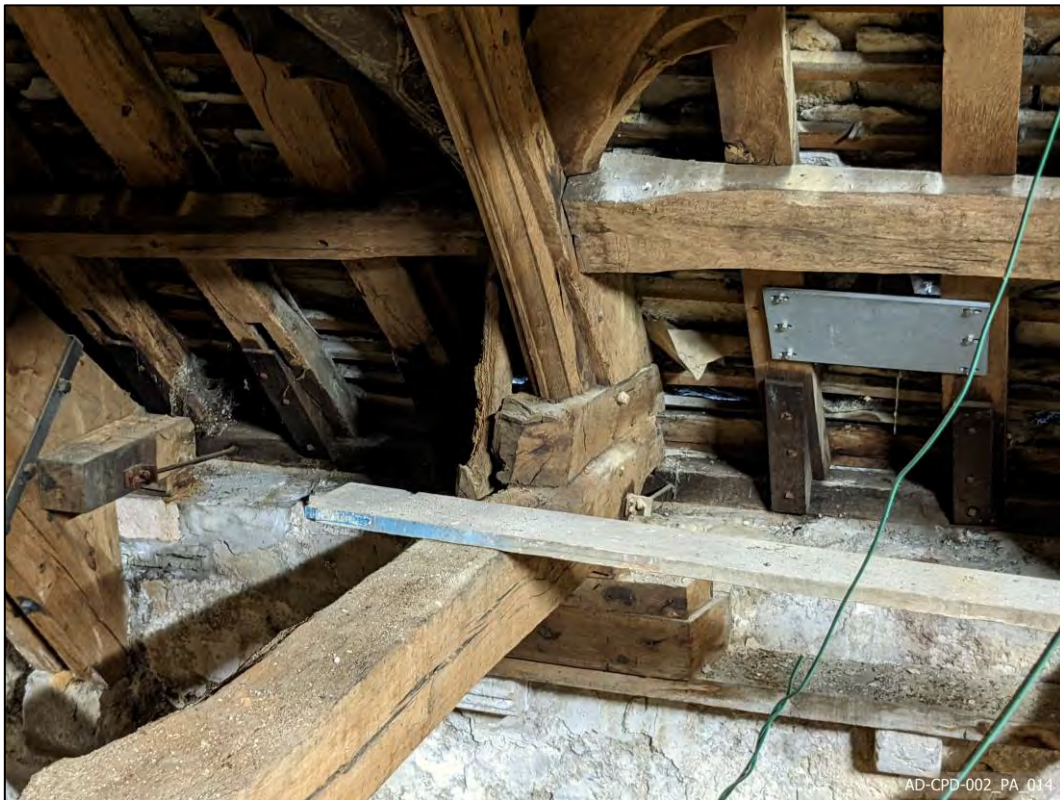
Plate 14 – Truss 2 – South – Alterations to original sole plate

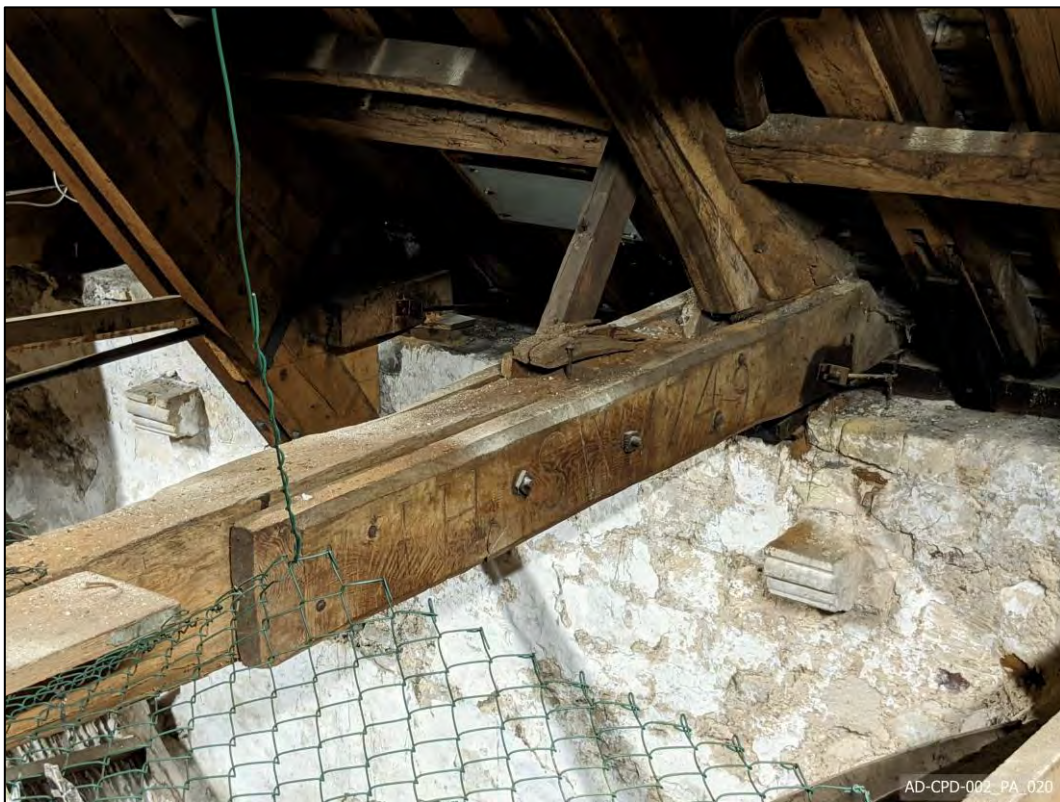
- 5.4.1 After the works to strengthen the roof of Phase II, there are no clear signs of work until 1749, when repairs were undertaken the tie-beam of Truss 6. This was followed by subsequent work in 1784, 1819 and 1823, all of which are marked in pencil.
- 5.4.2 Shipping marking on one of the 1819 repairs demonstrate that the pine used to reinforce the purlins was imported from the Baltic region.
- 5.4.3 The most recent addition to the roof was the addition of the intermediate trusses, to support the centre of the purlins.

Plate 20 – Truss 9 – 1749 repair to tie-beam

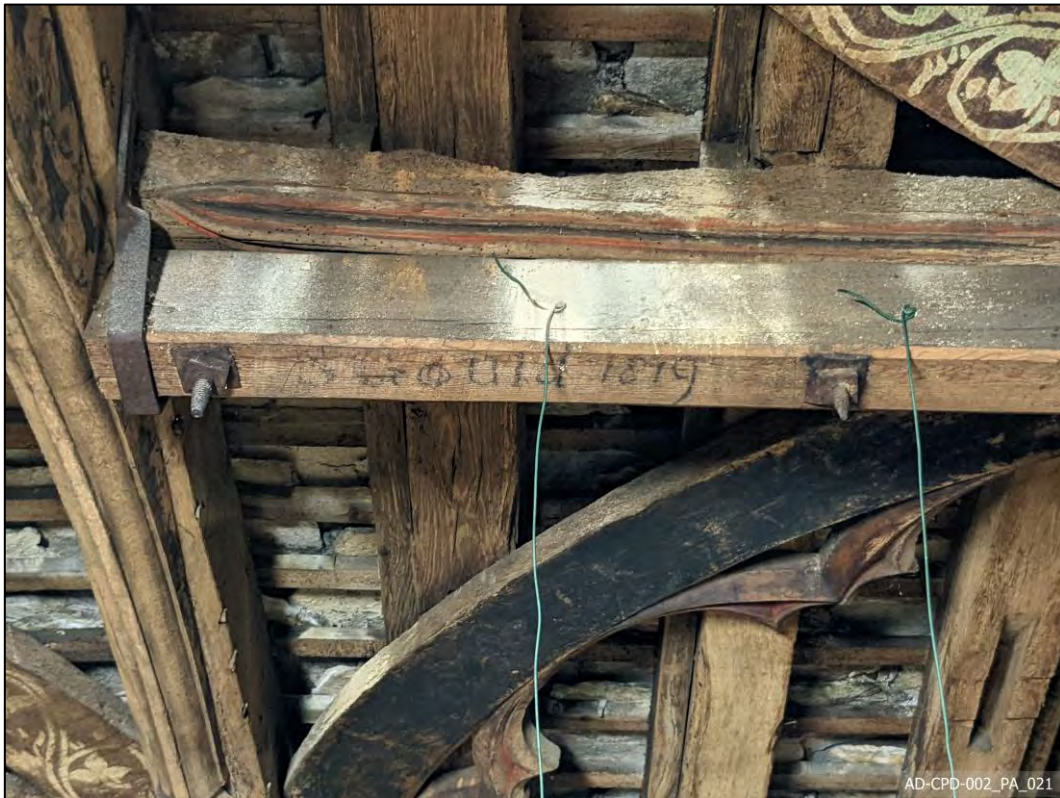
Plate 21 – Bay 4 – 1819 strengthening to purlin

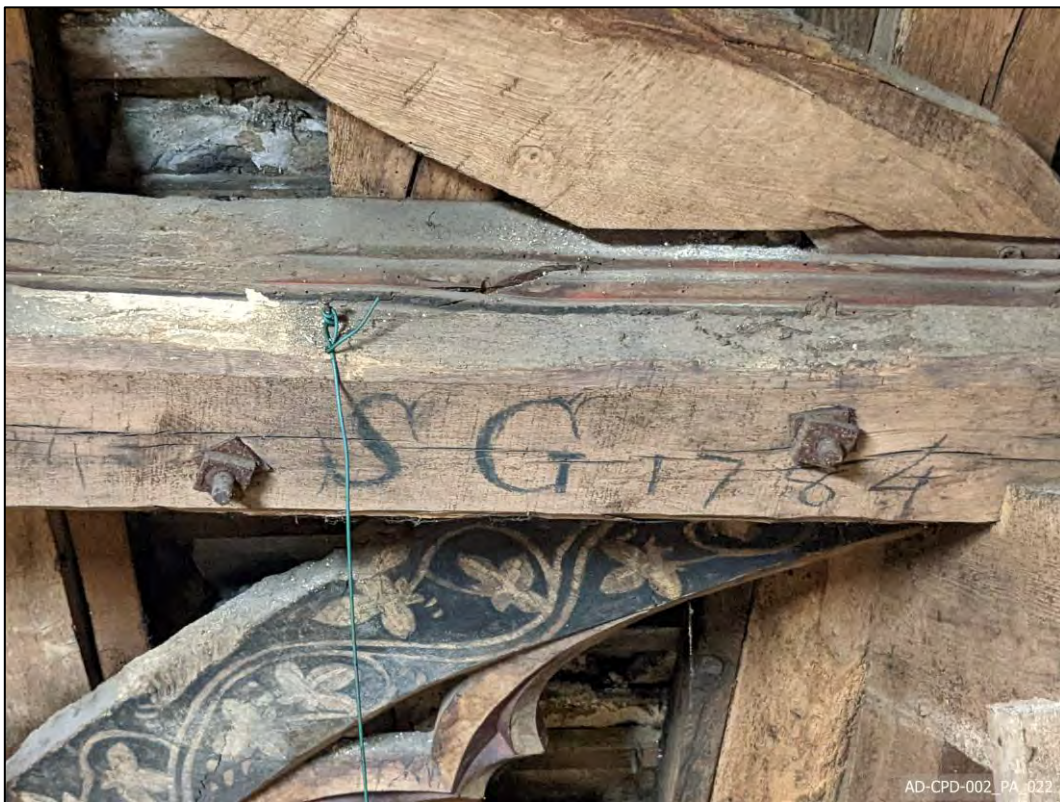
Plate 22 – Bay 13 – 1784 strengthening to purlin

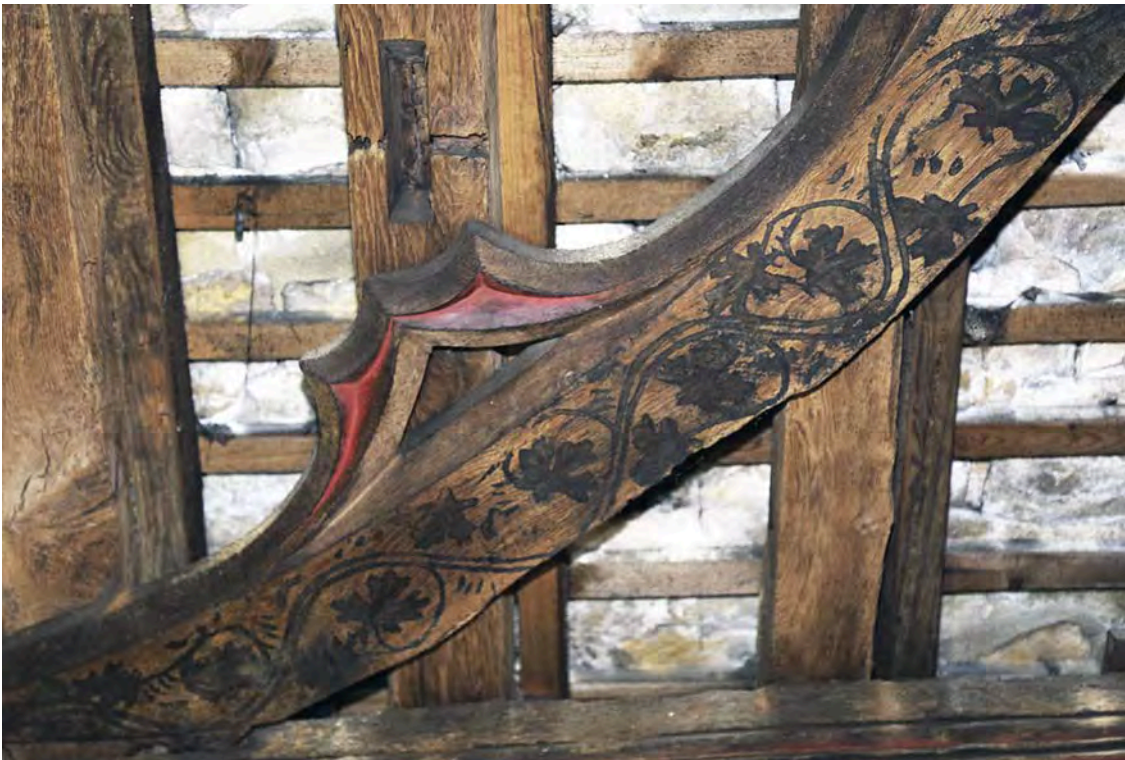
Plate 3

Top: example, windbrace with most of the black background lost and the vine trail surviving as a negative image (ie the colour on top has been lost leaving only the black background)

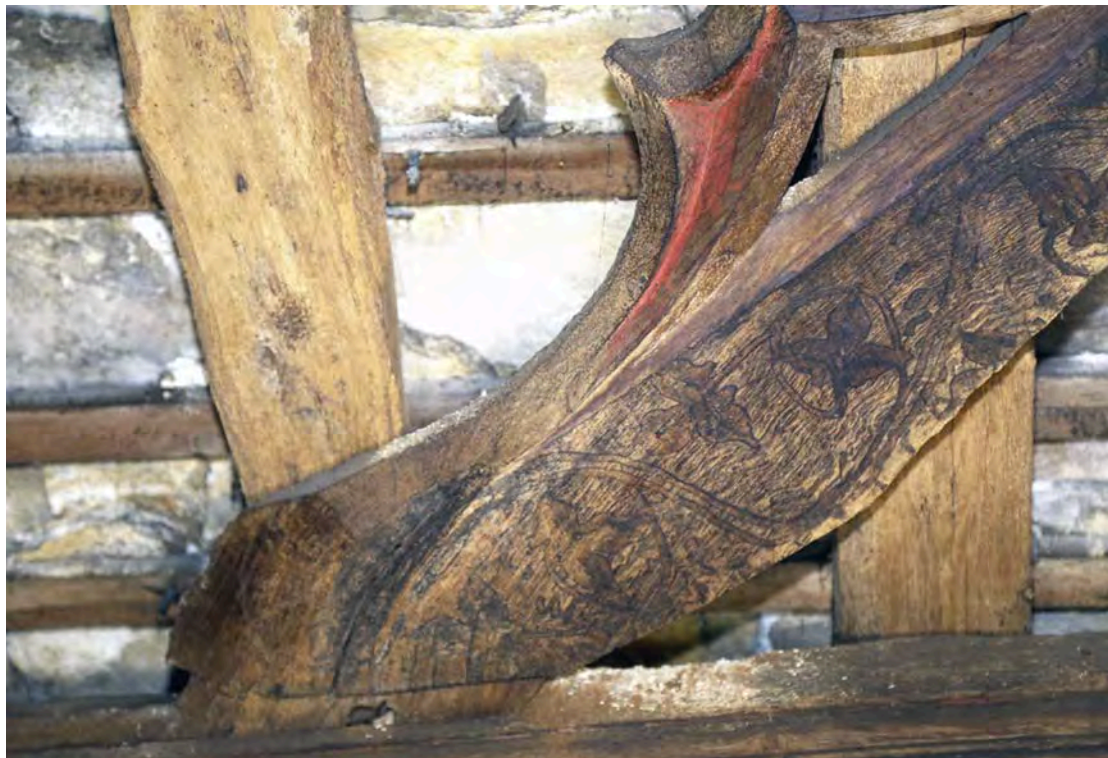
Plate 4

Bottom: example, windbrace with the background colour loss, some leaves and the outline of the vine stem survive as negative images
(All photos © A Kirkham 2022)

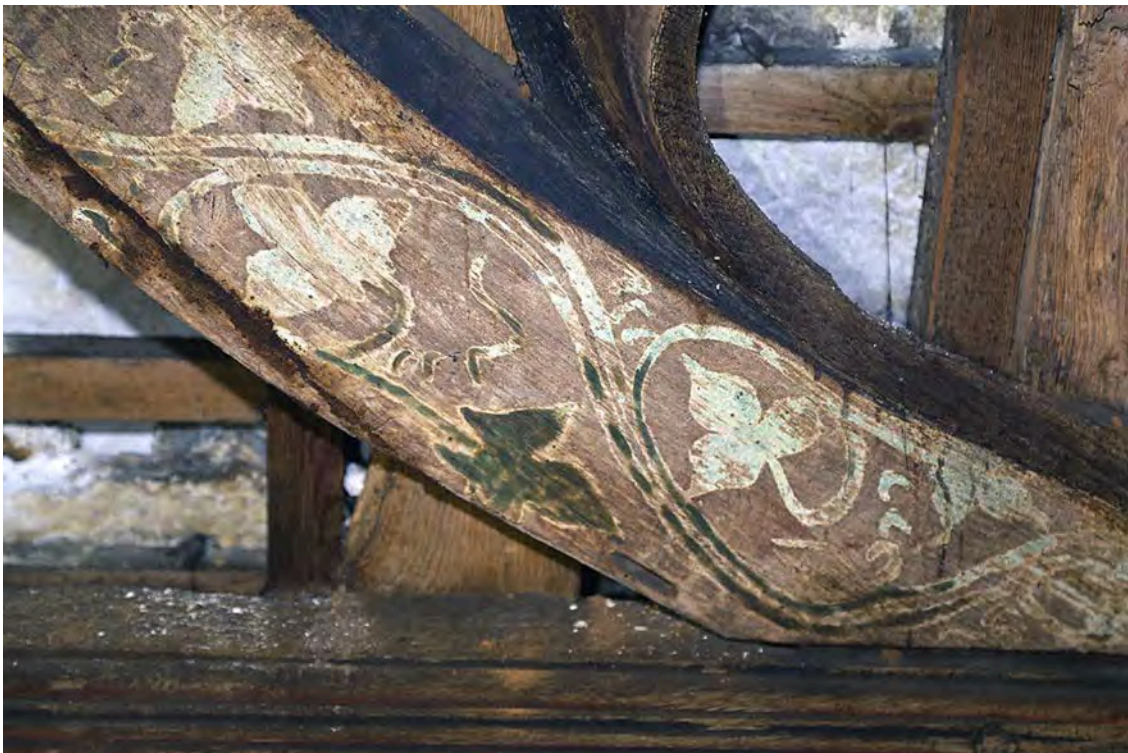
Bottom: example, windbrace with green foliage surviving, the rest mostly lost. Note also dust and debris on the purlin.

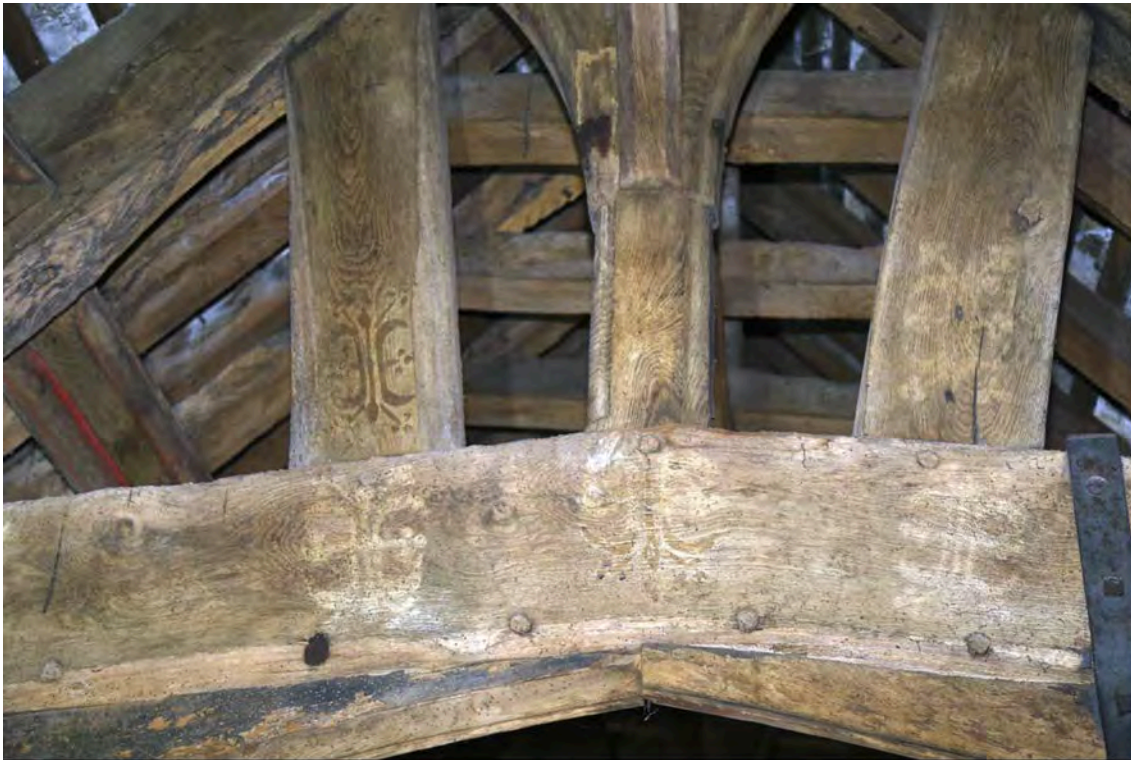
**Plate 15**

Top: example, showing differential patterns of loss. The paint survives in a variable state from one motif (?stenciled) to another

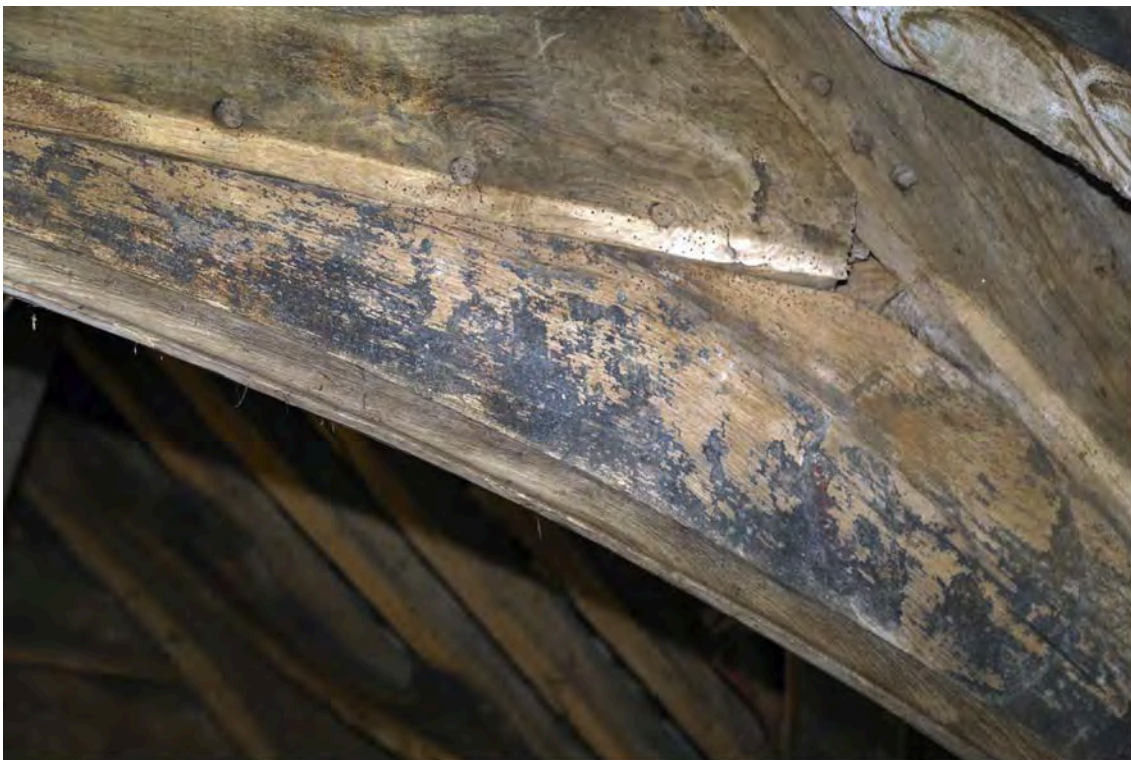
Plate 16

- 4.5: There is no evidence at present, for residues of later overpaint which might have been applied during one of the repair phases. Areas of thinned and abraded paint suggest that cleaning has been carried out at some point.

Bottom: example detail, brace with abraded paint
(All photos © A Kirkham 2022)

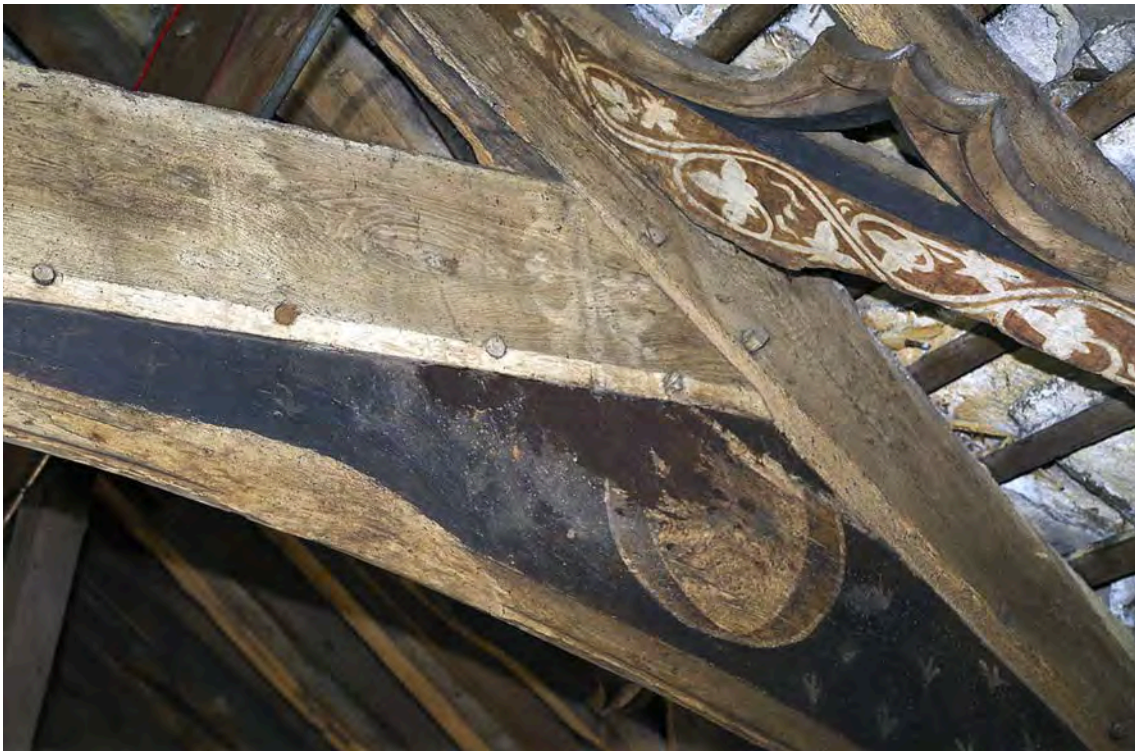
**Plate 17**

Top: example, archbrace, with a moon motif, disfigured by a discoloured repair

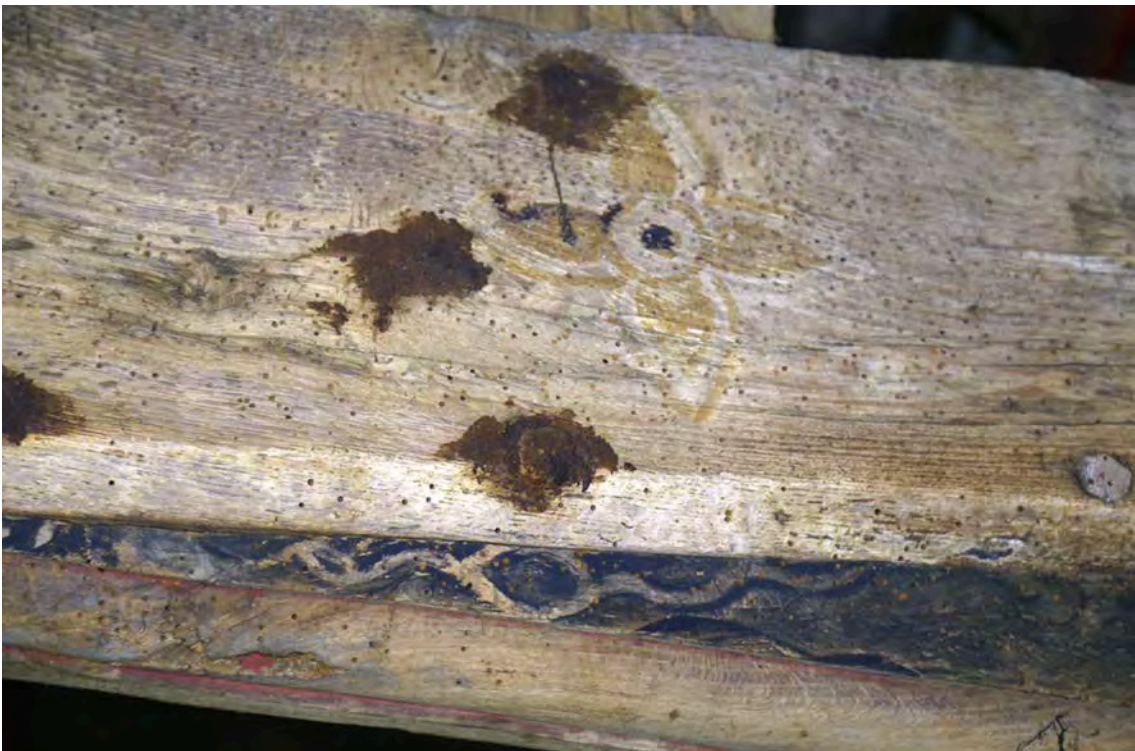
Plate 18

Bottom: example, collar showing the remains of a petalled floral motif, disfigured by discoloured repairs. Note also, insect damage
(All photos © A Kirkham 2022)

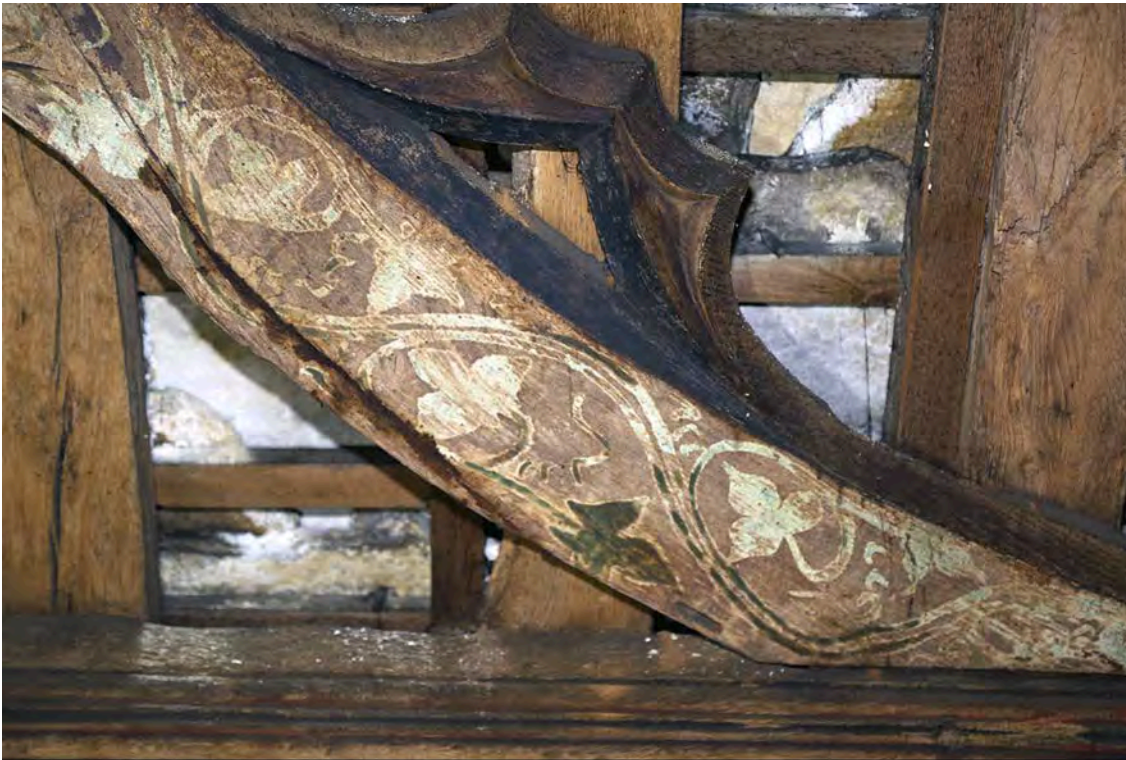
**Plate 19**

- 4.6: There is evidence of timber decay and insect damage (plates 23-24).
- 4.7: Splits and damages in the timber have been repaired in the past, and these have now discoloured to such an extent that they are visually intrusive (There are numerous areas, selected examples can be seen in plates 19-20, 22).

Top: example, windbrace with discoloured split repair. Note also dust and debris on the purlins. Dust and debris is visible on the purlin

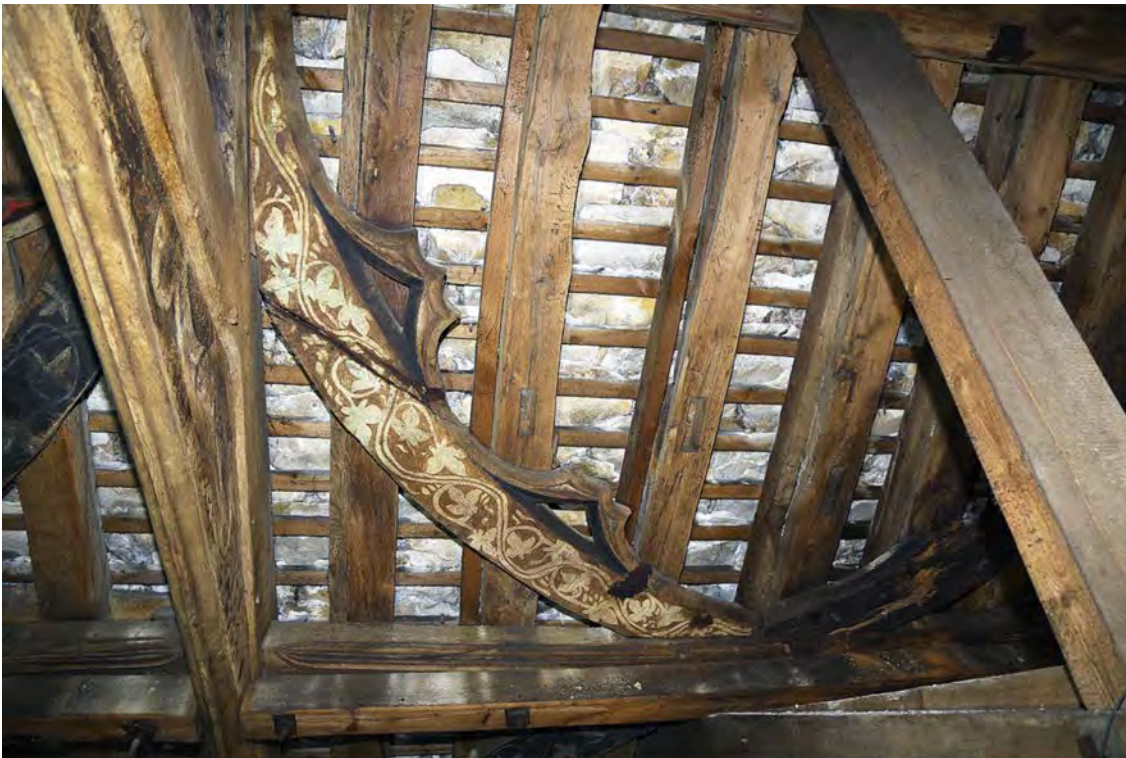
Plate 20

Bottom: example, windbrace with discoloured split repair
(All photos © A Kirkham 2022)

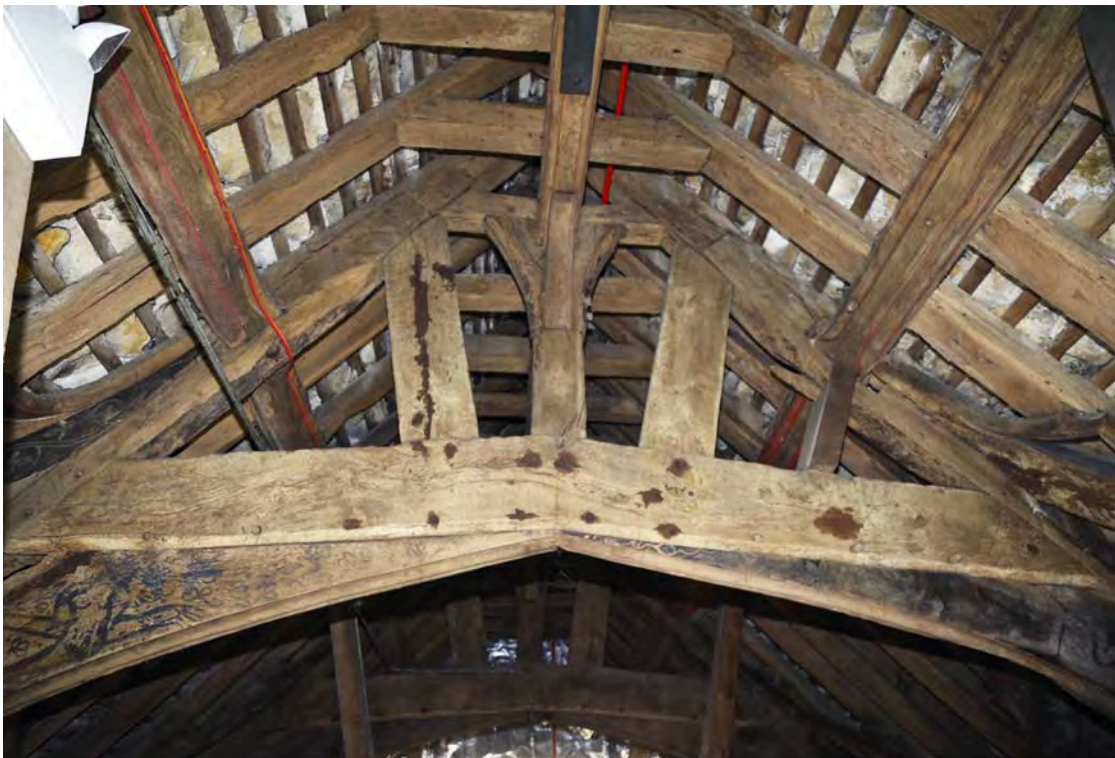
Bottom: example merfolk truss with discoloured repairs that are now visually disturbing. Compare with plate 21 above which has not been repaired

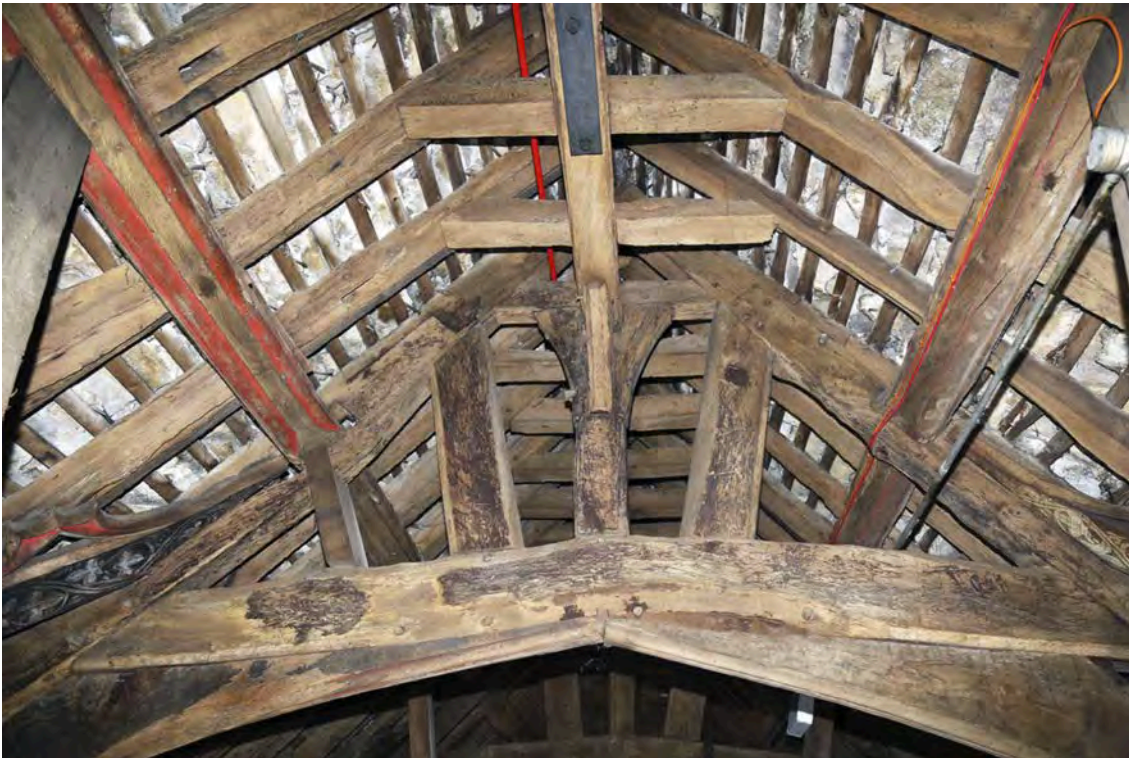
**Plate 23**

Top: example showing timber decay with the collar badly affected. Note also the richness of the red where it survives on the upper side purlins

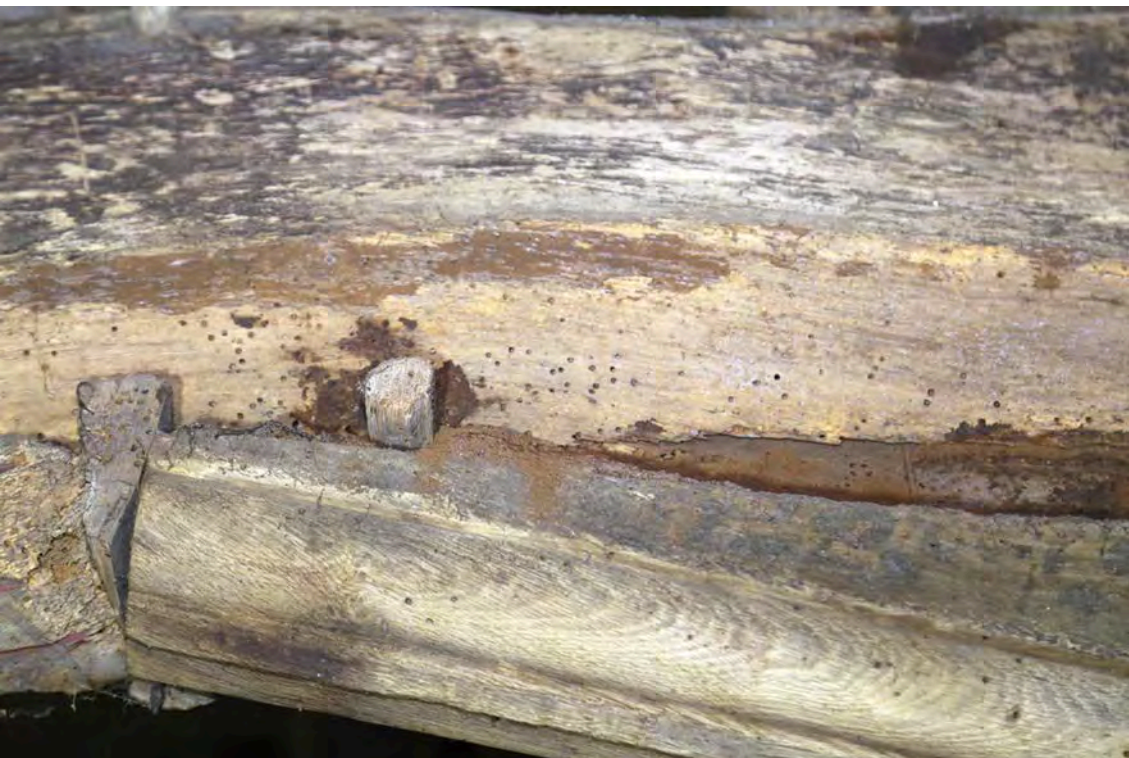
Bottom: detail of plate 23 showing insect damage and frass
(All photos © A Kirkham 2022)
